File 119: Resimetal 101 Metal Repair Paste, a high strength composite used as a proven solution in **Plate Bonding** to damaged tanks. CUI was caused by outdated rockwool and cladding system that caused severe corrosion, deep pitting, and metal loss.

Renroc ESP specialises in the refurbishment of previously insulated (rockwool/clad) process Plant and Equipment damaged by undetected **C**orrosion **U**nder **I**nsulation.

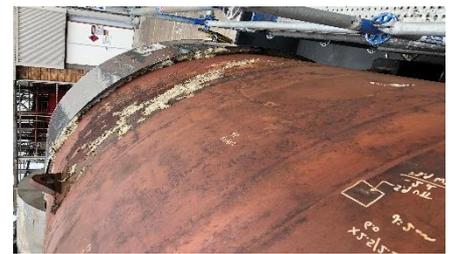
1. Outdated rockwool insulation and cladding completely masks CUI and the damage can be catastrophic as cladding allows seepage and the rockwool absorbs and holds in the moisture and promotes undetected CUI

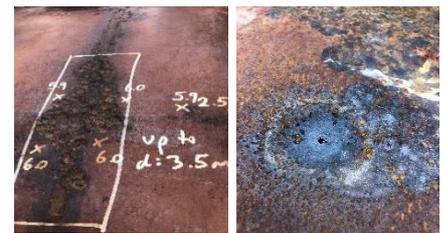
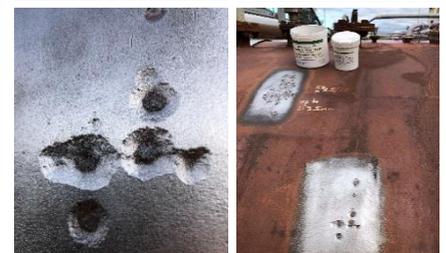
2. The affected metal surface was extensively pitted and dangerously low in thickness in some areas with deep pitting and metal loss. Once determined it was structurally sound it was then Bristle Basted and ready for specialist Renroc ESP Plate Bonding process. The surface preparation was to our specification of Sa3 White Metal cleanliness and 75 Micron surface roughness/profile depth.

The NaOH tank was stripped of the rockwool and lagging, and metal thickness testing was done across the tank. The worst of the pitted zones were prepared to Sa3 White metal cleanliness with a surface roughness profile of 75 microns (peak to valley) depth. This was achieved by using purpose designed Bristle Blaster power tools in situ without the dust and grit associated with Abrasive Blasting.

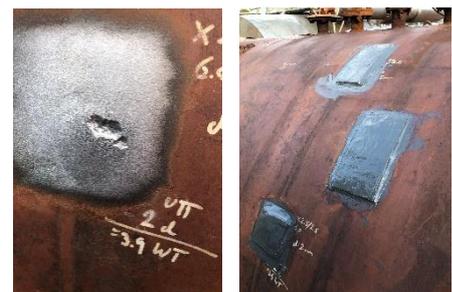
3. The metal plates were also overcoated and fully encapsulated for additional strength and durability. This Renroc ESP method and service saved the Power Station expensive shutdown time and money as well as eliminating any safety/environmental issues associated with leakage of NaOH from these tanks..

Renroc ESP specialist Technician prepared and applied the high strength Resimetal 101 Metal Repair Paste in situ to the prepared areas. It was also applied to the underside of specially made sections of metal plates which were wet fitted and attached the worst areas of concern as the Demin plant couldn't afford to shutdown these tanks and their process.
